Comparative Evaluation of Flashing Beacon Devices in Santa Monica

By: Sam Morrissey, P.E., T.E. and Steve Weinberger, P.E.

Abstract

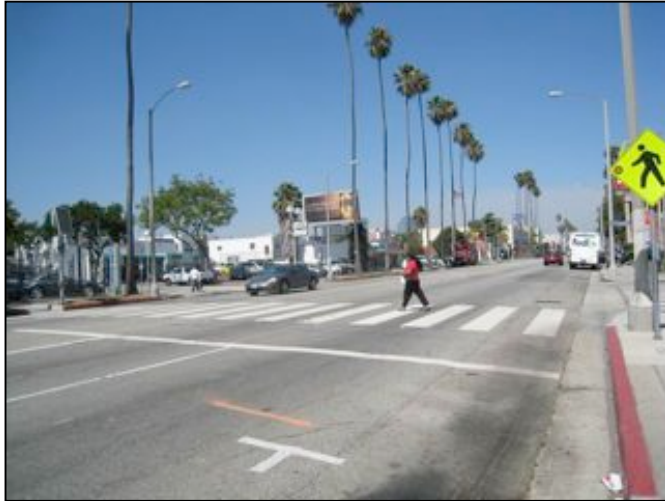
The Santa Monica Boulevard/Princeton Street test site consists of a marked crosswalk on Santa Monica Boulevard across the uncontrolled eastern leg of the intersection. Santa Monica Boulevard is a Principal Arterial. Stop controls are provided on Princeton Street, the minor side street approaches to Santa Monica Boulevard. The intersection is offset, with the segment of Princeton Street south of Santa Monica Boulevard located approximately 30 feet west of the segment to the north.

Lane Geometrics, Width, and Striping – In the vicinity of the test site, Santa Monica

Boulevard has a curb-to-curb width of approximately 68 feet, with five travel lanes (two travel lanes in each direction and a center two-way left turn lane) and two eight-foot parking lanes.

Crossing Enhancements – A high visibility “continental” pattern crosswalk is marked across Santa Monica Boulevard. There are advance “Ped Xing” pavement markings to the east and west of the crossing as well as advance stop bars on both approaches to the crosswalk. On the eastbound approach, the stop bar is located approximately ten feet from the crosswalk. On the westbound approach, due to the offset configuration of the intersection, the stop bar is located approximately 65 feet from the crosswalk. Overhead street lights located on each side of the crosswalk, provide illumination of the crossing at night.

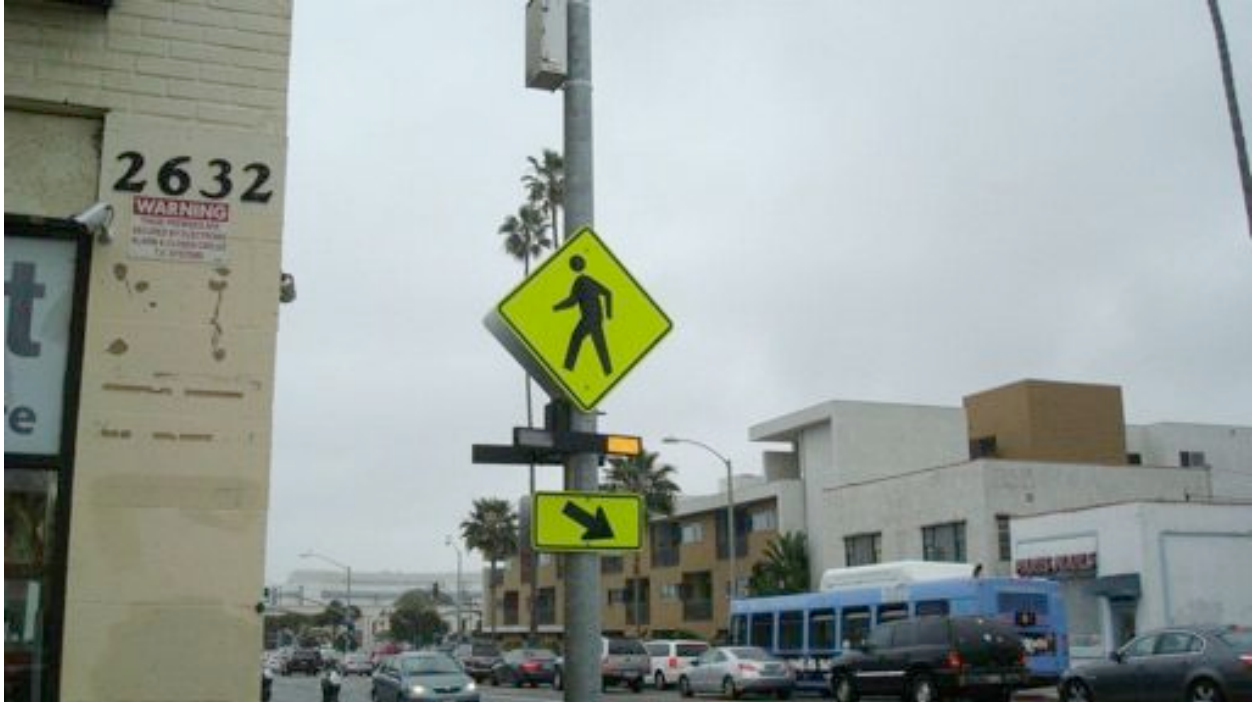
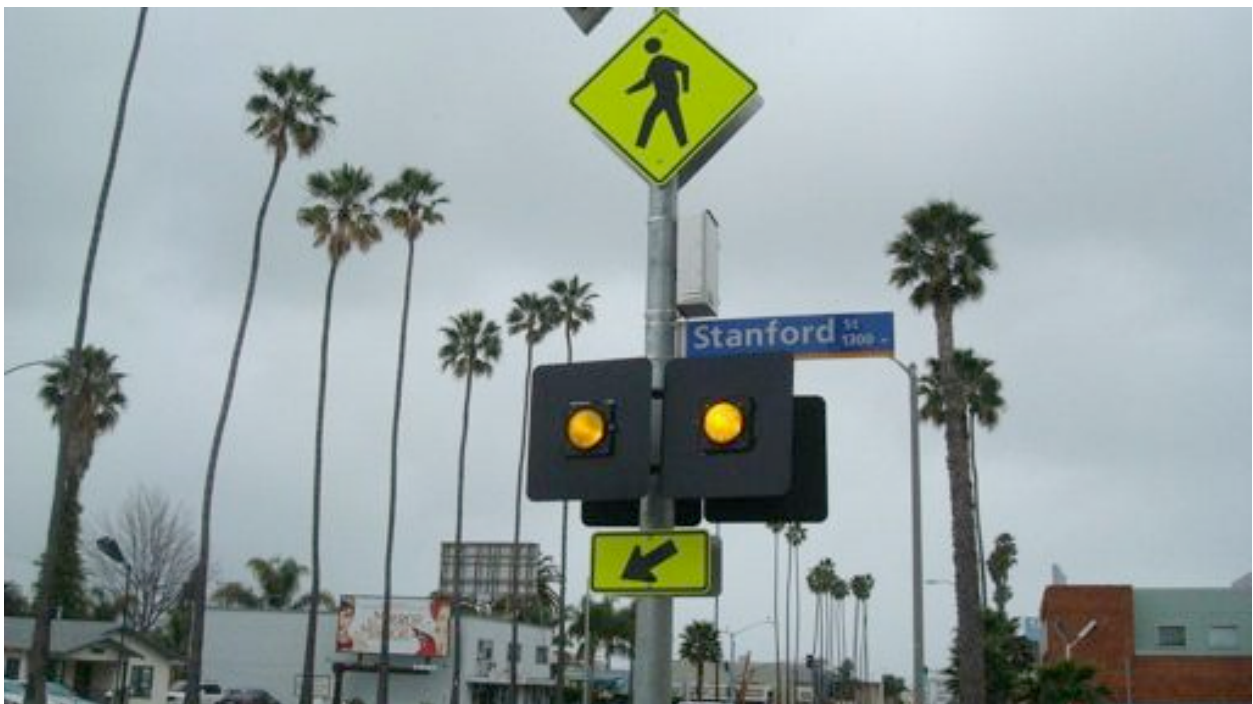
The photos below show the flashing beacon systems as installed. The first photo shows the RRFB at the intersection of Santa Monica Boulevard/Princeton Street, while the second photo shows the CRFB at the intersection of Santa Monica Boulevard/Stanford Street.

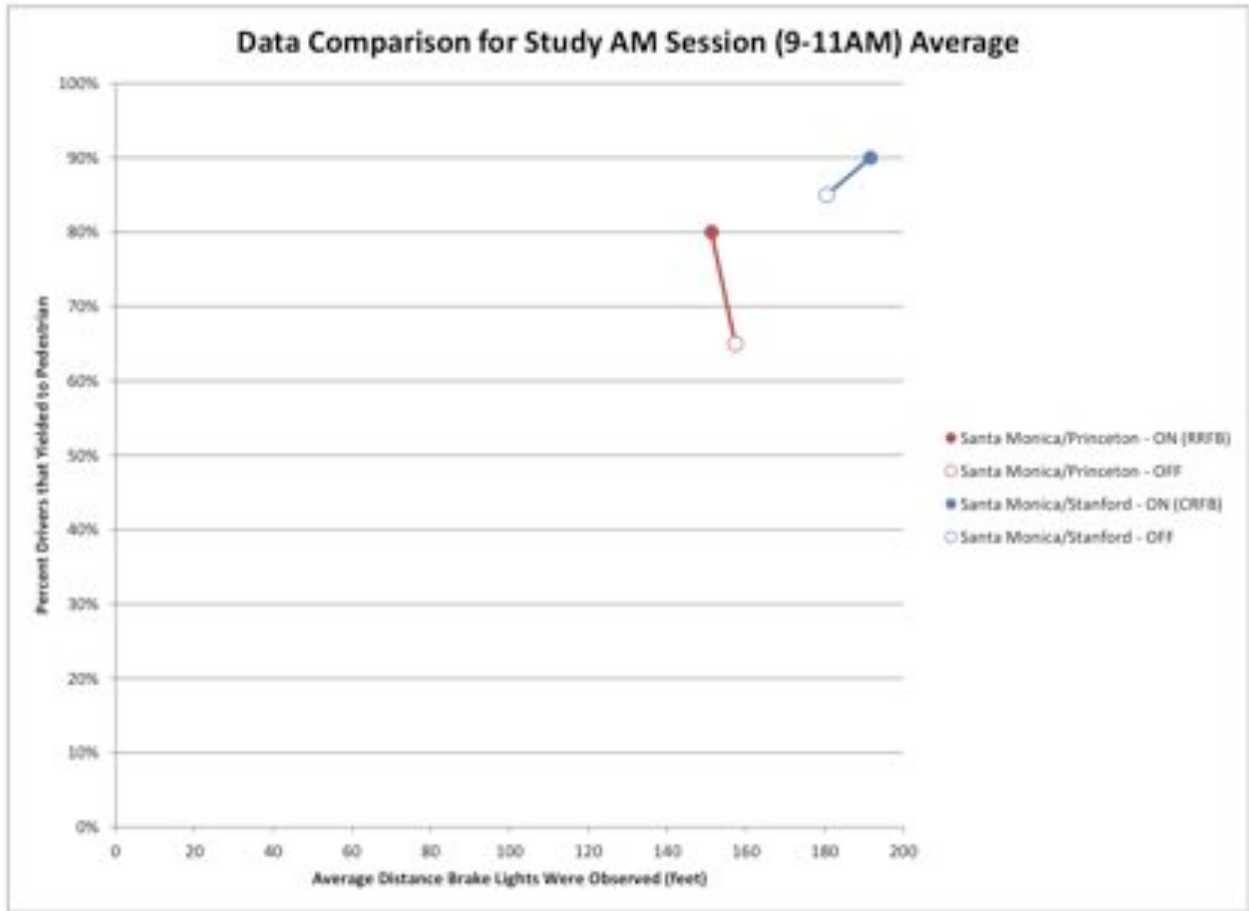
The first of the planned evaluations occurred in January 2012. The chart below shows the results of the morning evaluation for both the RRFB at Santa Monica Boulevard/Princeton Street and the CRFB at Santa Monica Boulevard/Stanford Street. On the chart, the solid dots represent driver yielding response rates when the flashing beacon is activated, while the unfilled dots represent driver yielding response when the flashing beacon is inactive.

As shown in the figure above, driver yielding responses when the devices were inactive were approximately 65% and approximately 85% at the intersections on Santa Monica Boulevard with Princeton and Stanford Streets, respectively. When the beacons were activated, the RRFB increased driver yielding responses by about 15%, to approximately 80%, while the CRFB increased driver yielding response by about 5%, to approximately 90%.

Location:		Santa Monica/Princeton	Santa Monica/Stanford
Device:		RRFB	CRFB
Time of Day	State of Operation	Yielding Response (Approx.)	
AM	Off	65%	85%
	On	80%	90%
	Change	+15%	+5%
Midday	Off	70%	90%
	On	90%	95%
	Change	+20%	+5%
PM	Off	85%	75%
	On	85%	90%
	Change	0%	+15%
Dusk	Off	85%	75%
	On	80%	100%
	Change	-5%	+25%
Night	Off	60%	80%
	On	95%	90%
	Change	+35%	+10%

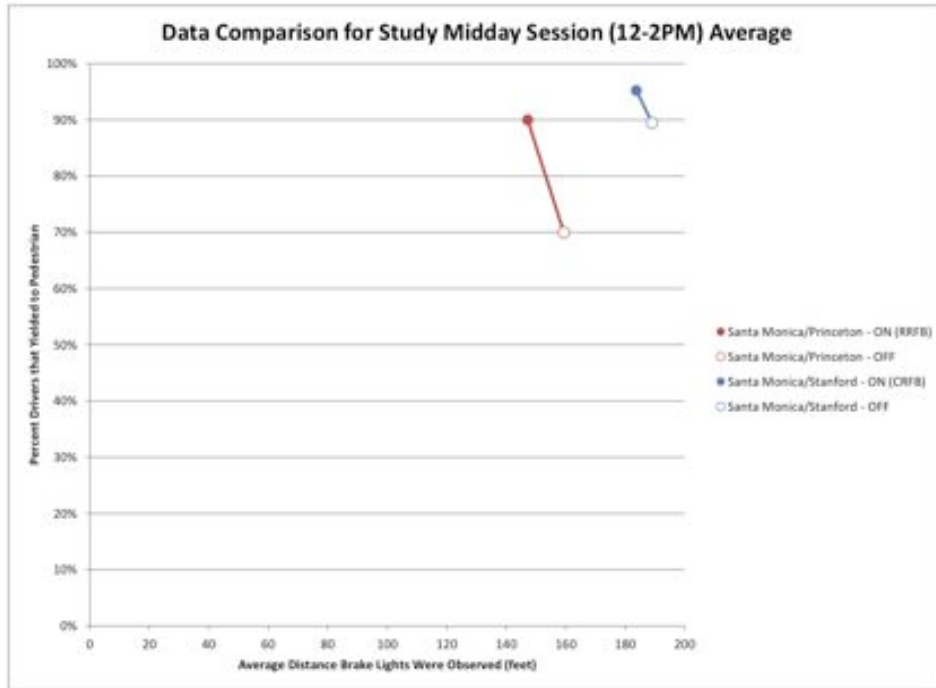
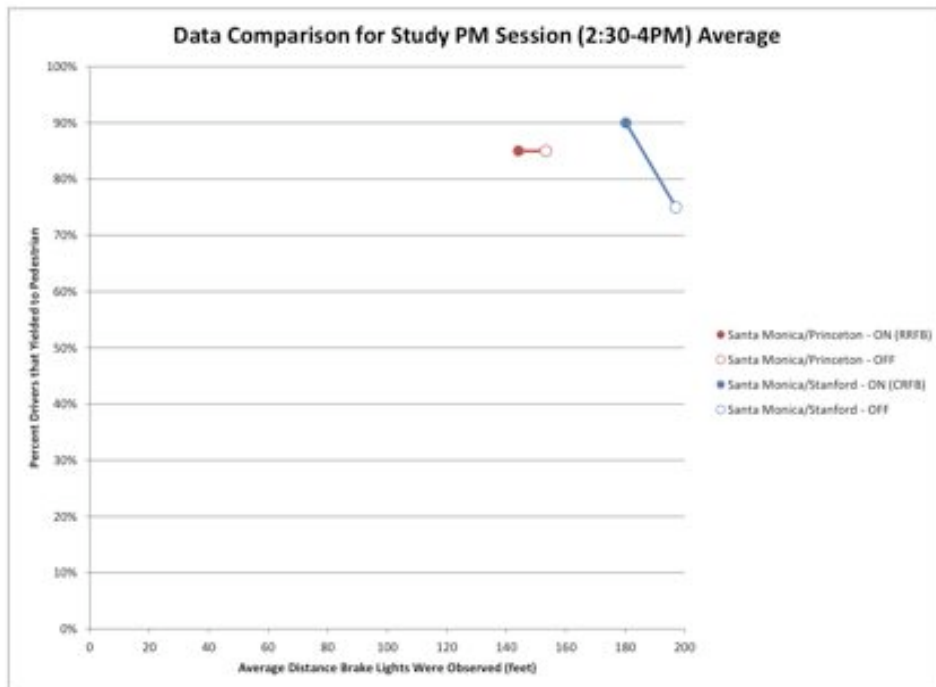
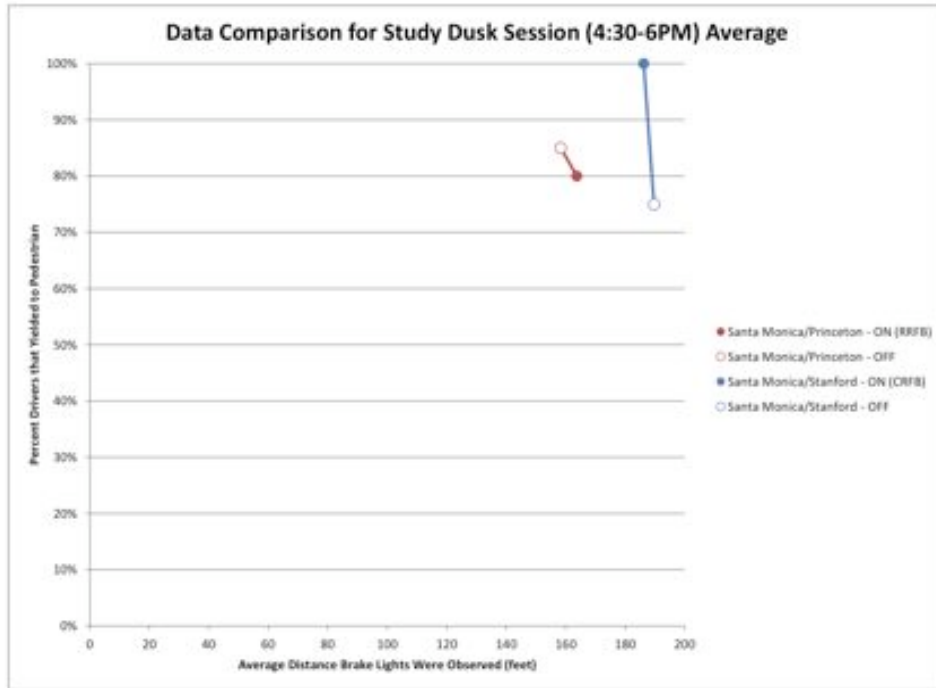
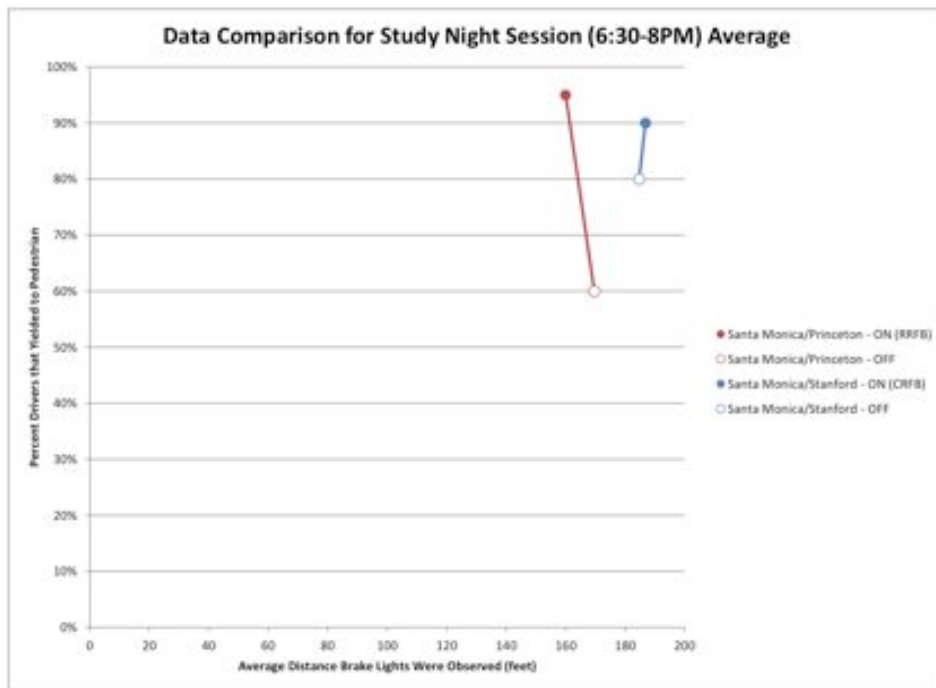
Similar results were found during the other evaluation periods. The charts for midday, afternoon, dusk, and nighttime evaluations are presented on the following pages below.

In general both devices showed increases in driver yielding response rates when activated, except in one situation. The table below presents a summary of the changes to driver yielding response rates when the devices are activated.

From the field evaluations, it is unclear what caused the decrease in driver yielding response rates for the RRFB during the dusk evaluation. The detailed evaluation data shows that the decrease in yielding response rates occurred only in the westbound direction on Santa Monica Boulevard, and the eastbound direction actually showed no change in yielding response rates whether the RRFB was activated or not (90% for both states of operation). Therefore, it is the opinion of the author that glare from the sunset at dusk was perhaps a factor in the reduction in driver yielding responses. Further testing will be conducted to determine if this is a factor.

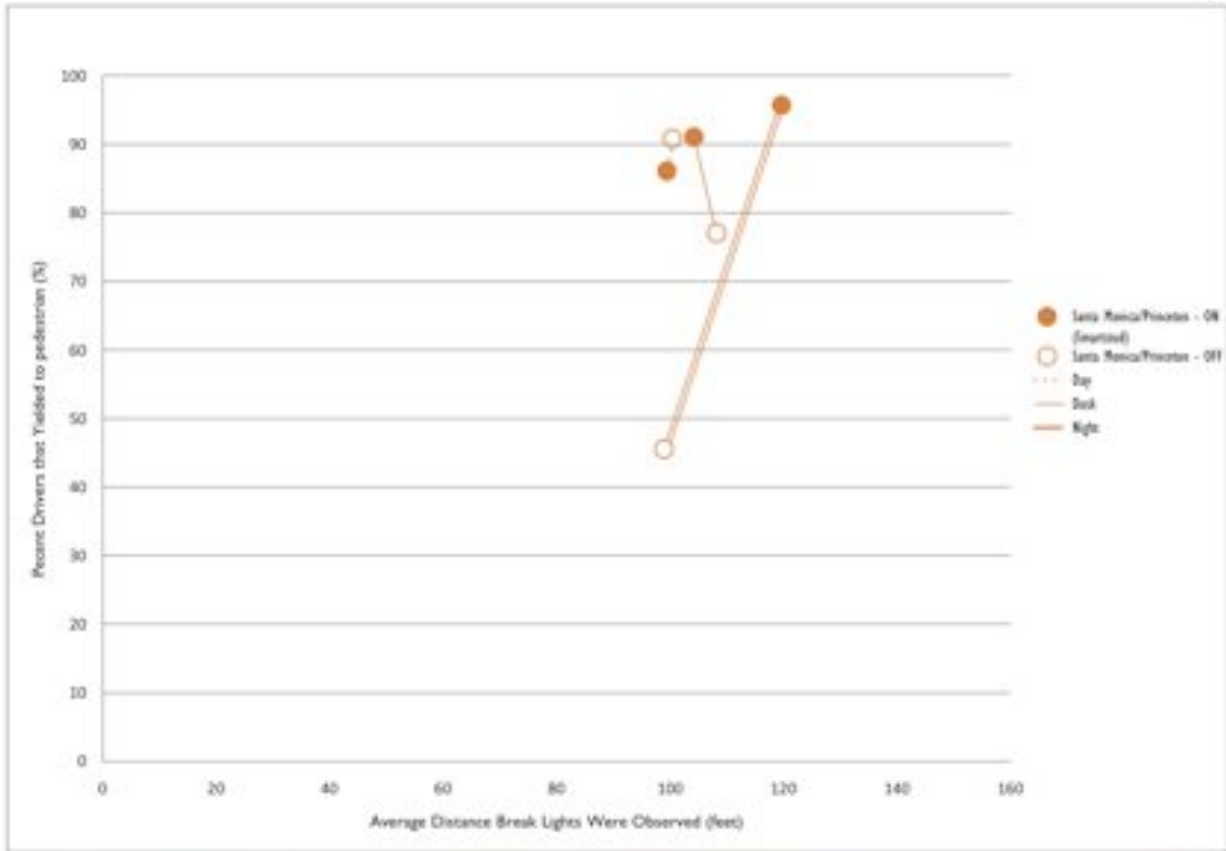
For comparison, the chart below shows a summary of the evaluation results for the intersection of Santa Monica Boulevard/Princeton Street when an IRWL system was in-place.

As shown above, the IRWL system increased driver yield response rates at Santa Monica Boulevard/Princeton Street by approximately 5%, 13%, and 50% during daytime, dusk, and evening conditions, respectively. Overall driver yielding response rates for the IRWL system were between approximately 87% and 95%. The initial evaluations of the RRFB system at the same location show driver yielding response rates between approximately 80% and 95%. Based on these initial evaluation results, it appears that both types of flashing beacons, RRFB and CRFB, appear to be as effective as IRWL systems.
